Management Measures to Control Nonpoint Source Pollution from Expressway

Korea Expressway Corporation Research Institute

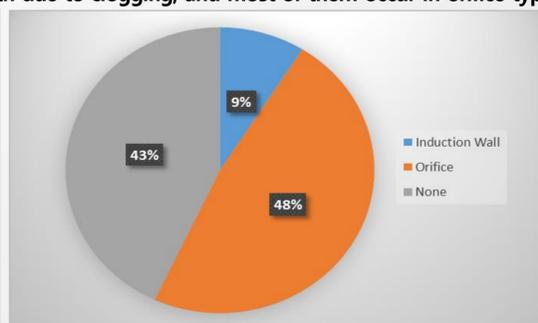
<Inlet Type of Facility>

- 1,291 surveys completed (85.8%, total 1,505 sites)
 - Data that can be used for analysis were available in 1,138(88.1%) out of 1,291 sites in consideration of on-site conditions
- If there is no flow distribution structure, it accounts for 43.1% of total, 48.0% of the facilities in the form of orifices, and 9.0% of the facilities in the form of induction wall.
- Runoff into the nonpoint reduction facilities in not smooth due to clogging, and most of them occur in orifice types.

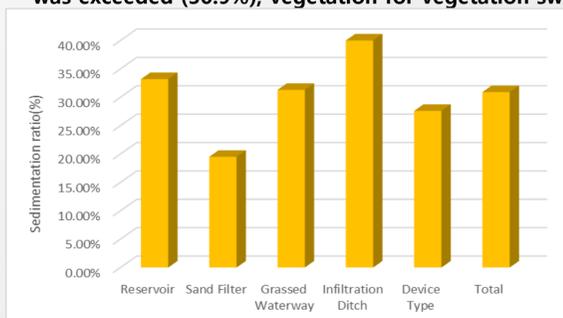
<Sedimentation ratio of Detention Basin>

- Among 1,138 facilities, 310 facilities (27.2%) had clogged inlet, 352 facilities (30.9%) had sediment deposited on pre-treatment tank and 421 facilities (37.0%) had overgrown vegetation.
- Filtration materials of sand filter were blocked (28.3%), infiltration ditch have reduced infiltration performance (61.3%), the amount of sediment for detention basin was exceeded (30.9%), vegetation for vegetation swale was insufficient (29.4%), and filter replacement is required for device type facilities (60.0%)
