Management Measures to Control Nonpoint Source Pollution from Expressway

Korea Expressway Corporation Research Institute

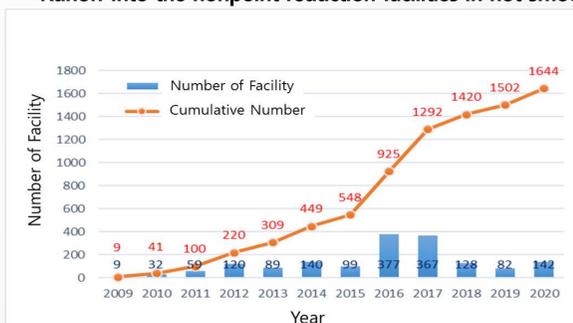
<Increase Trend of Facility>

- 1,291 surveys completed (85.8%, total 1,505 sites)
 - Data that can be used for analysis were available in 1,138(88.1%) out of 1,291 sites in consideration of on-site conditions
- If there is no flow distribution structure, it accounts for 43.1% of total, 48.0% of the facilities in the form of orifices, and 9.0% of the facilities in the form of induction wall.
- Runoff into the nonpoint reduction facilities in not smooth due to clogging, and most of them occur in orifice types.
